PROPERTY INSPECTION REPORT

Prepared For: John Sample Doe
(Name of Client)

Concerning: 1234 Any Street, Pearland, TX 77777
(Address or Other Identification of Inspected Property)

By: Chad Langston, Lic #7946 11/11/3000
(Name and License Number of Inspector) (Date)

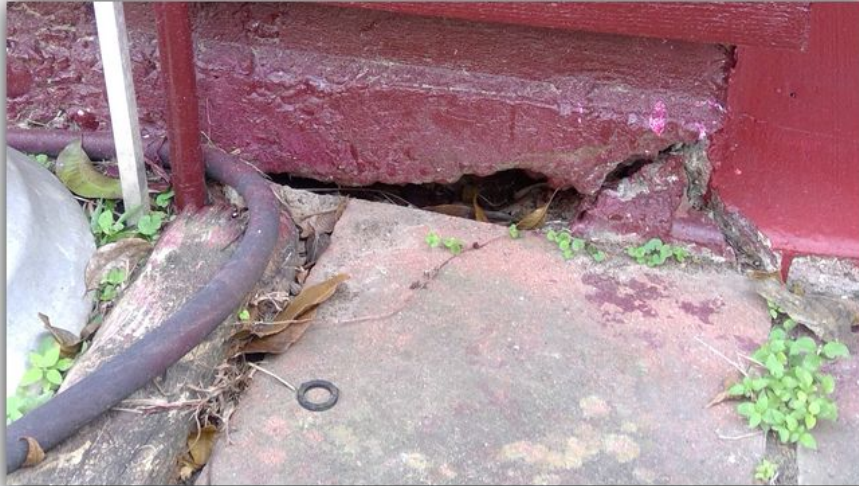
Soil erosion was observed under the rear corner of the home. Further investigation and repair should be made as necessary.

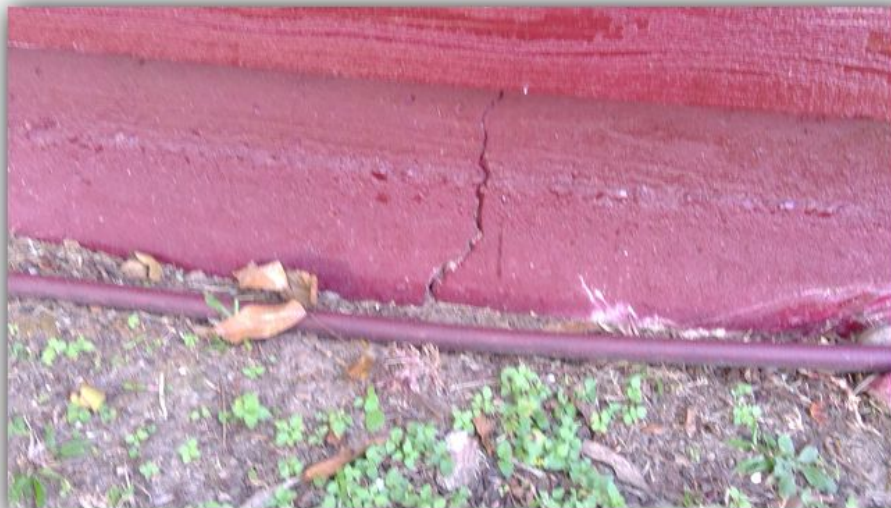
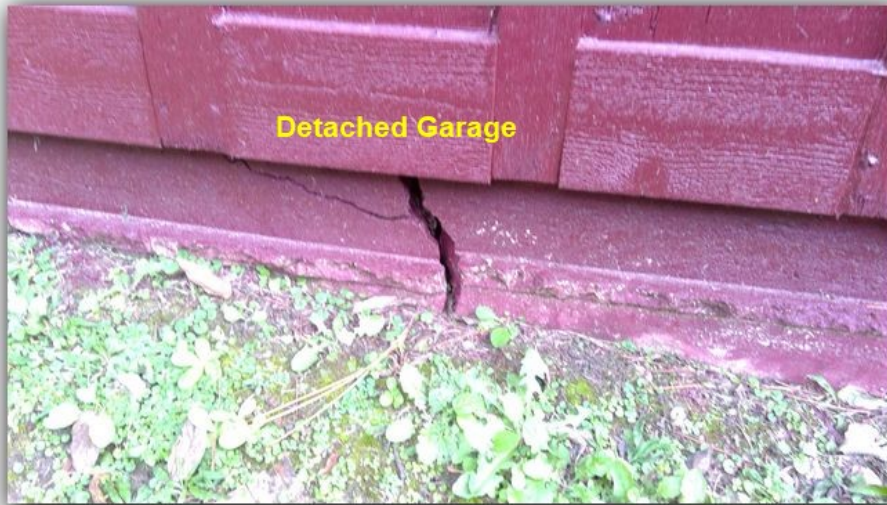
Substantial foundation cracking was observed. This implies that structural movement of the building has occurred. The rate of movement cannot be predicted during a one-time inspection. A structural engineer should be consulted to further evaluate this condition and the remedies available for correction.

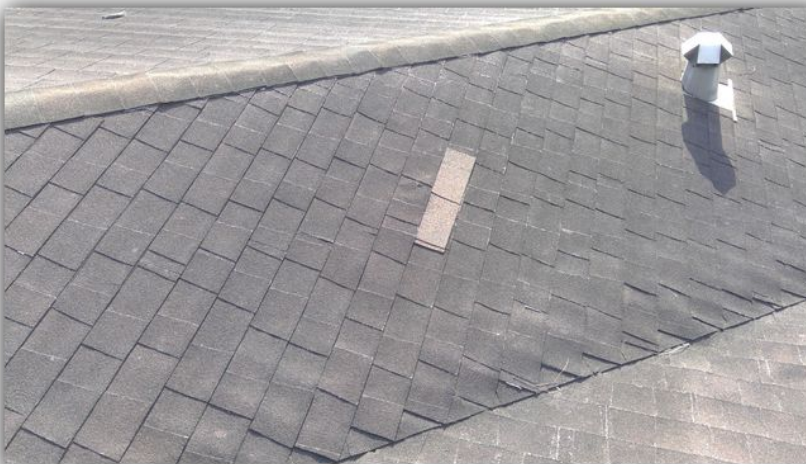
Prior repairs to the roofing are evident. This would suggest that problems have been experienced in the past. This area should be monitored.

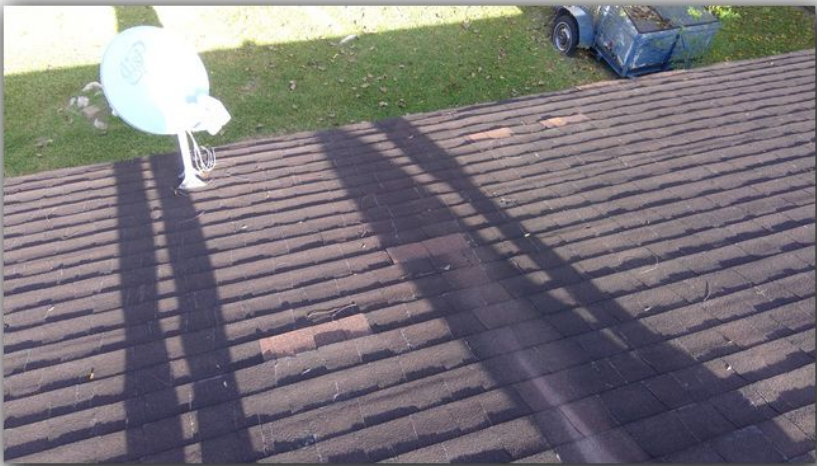
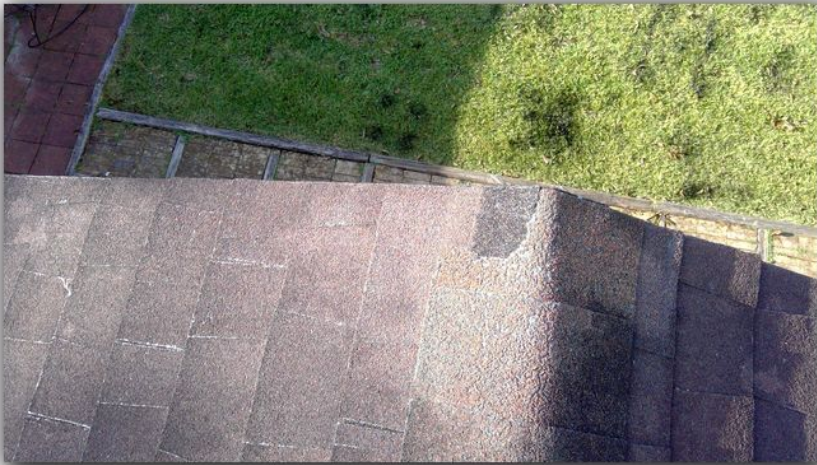
Minor repairs to the roofing are recommended. Damaged or missing roofing material should be repaired. All roof penetrations should be examined and sealed as necessary.

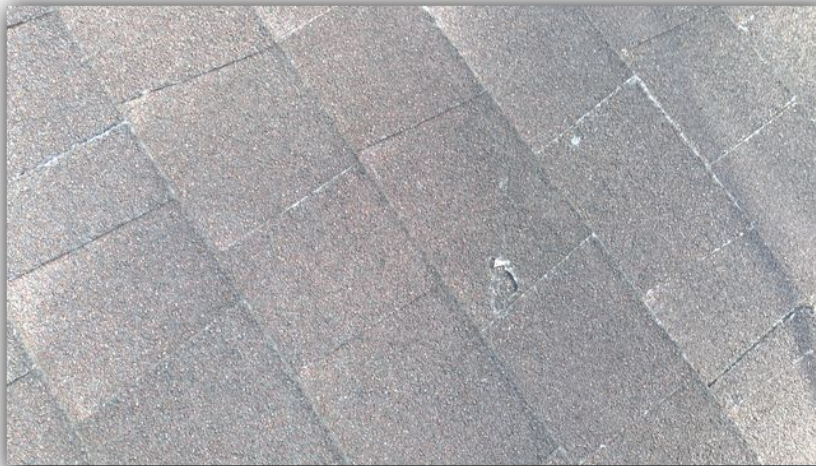
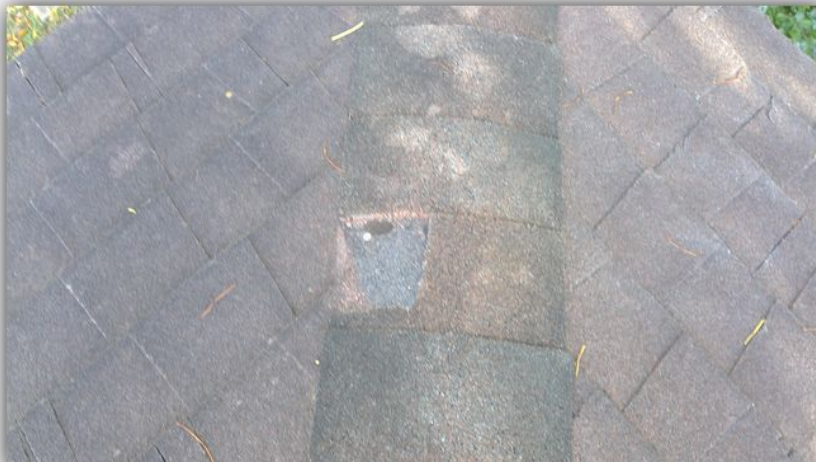
It appears there is more than one layer of roofing shingles installed on the home, but may be covered by felt and a metal drip edge. Further investigation would be needed to verify the number of layers.

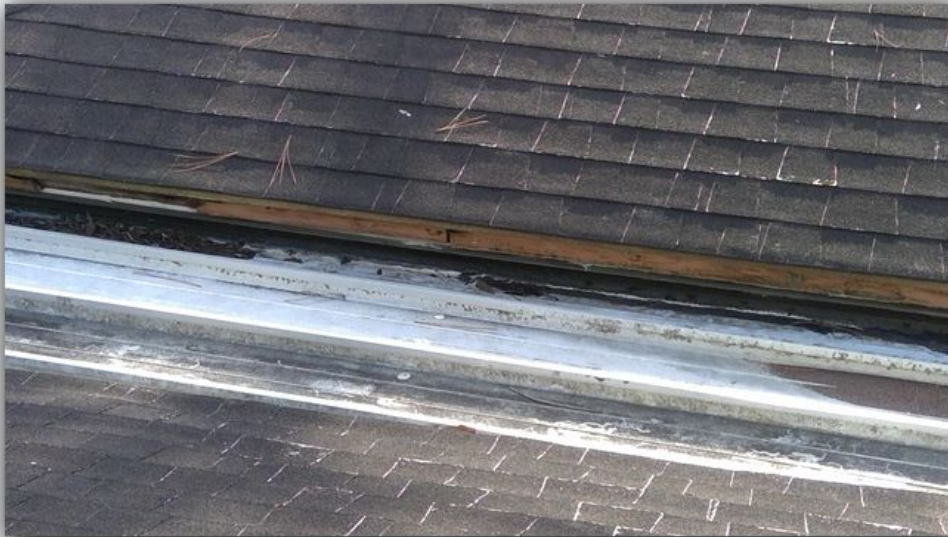
Water damage was noted on the fascia of the detached garage and should be replaced.

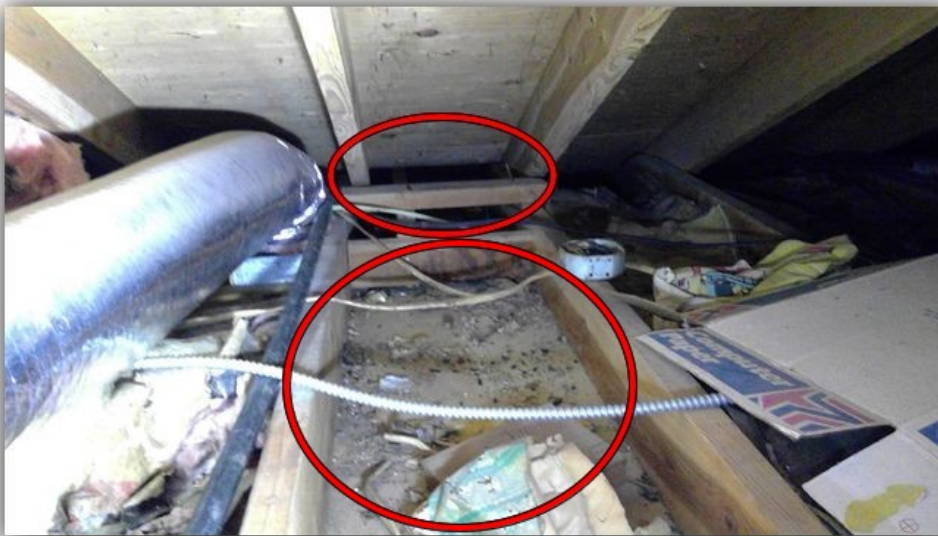
Missing insulation should be replaced.

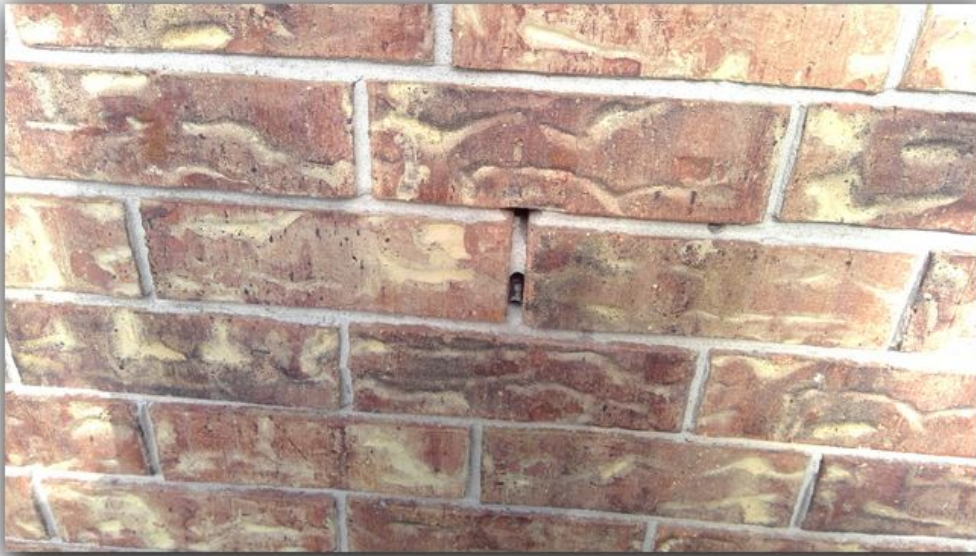
Mortar joints should be tuck pointed as necessary.

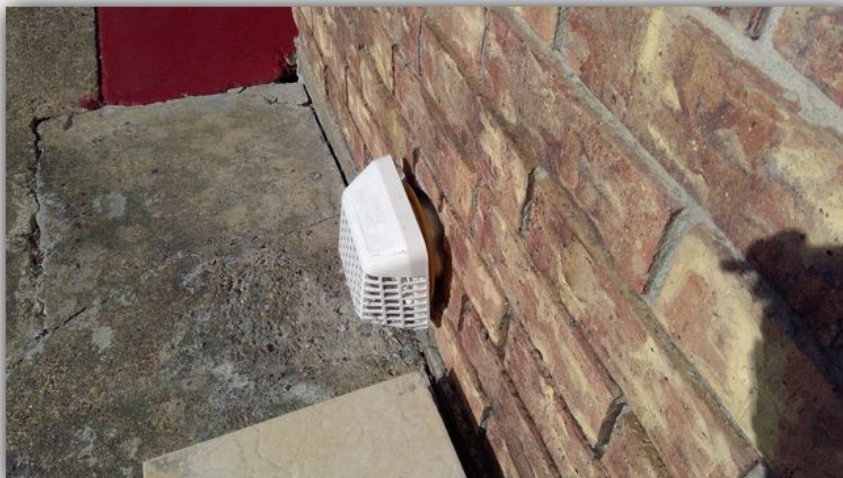
Exterior wall penetrations should be examined and sealed as necessary.

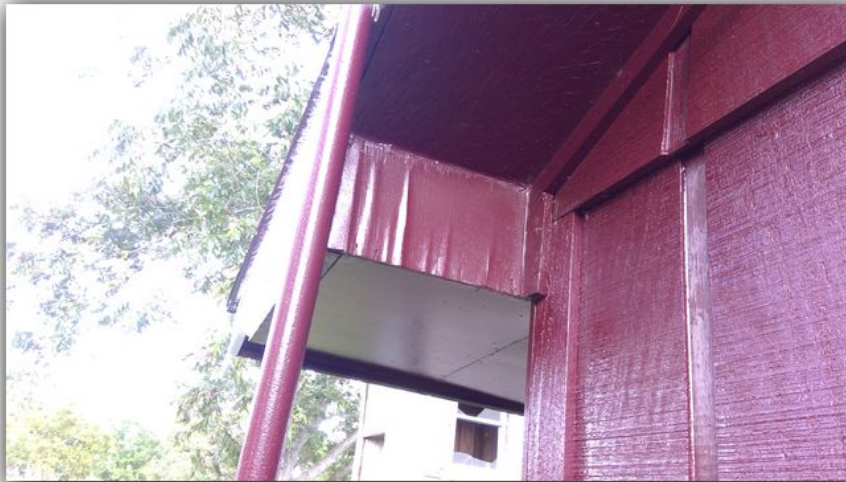
Water damage was noted on the exterior soffit/overhang. Repairs should be made as necessary.

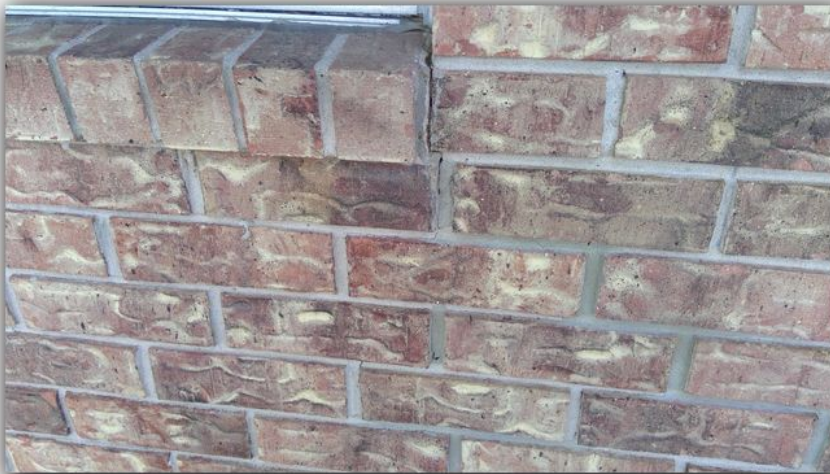
Signs of mortar repair were noted in the brick veneer. Typical reasons for this repair would include foundation settlement, or physical damage from an external force. Further investigation and/or repair may be necessary.

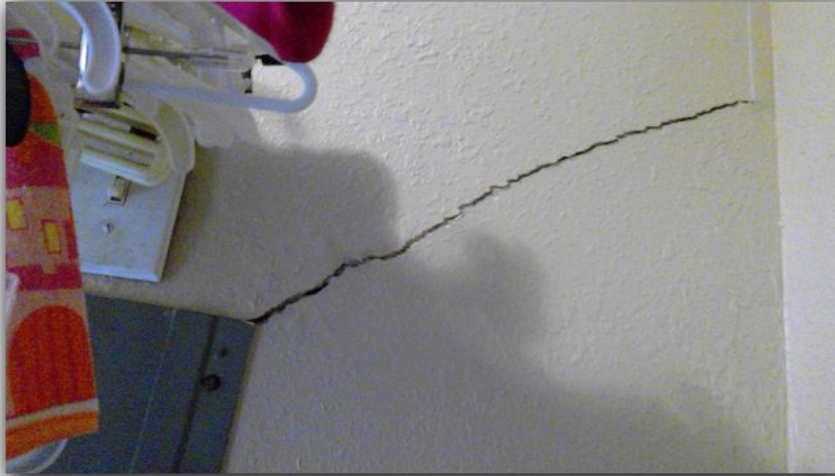
Bowing of the exterior wall structure was observed on the detached garage. This implies that structural movement of the building has occurred. The rate of movement cannot be predicted during a one-time inspection. A structural engineer should be consulted to further evaluate this condition and the remedies available for correction.

Larger than typical cracks were noted on the interior walls. This condition could indicate greater than normal movement within the structure and potential structural problems. Further investigation may be necessary.

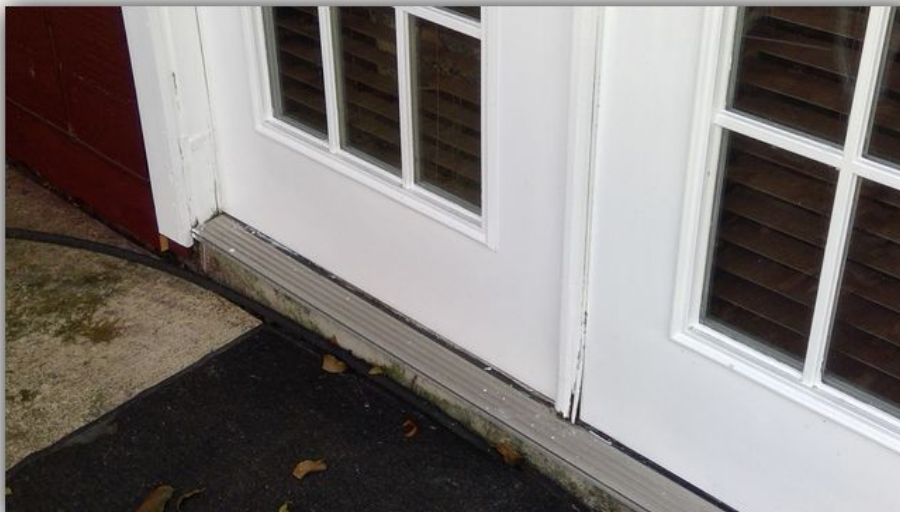
Water damage was noted at the side door at the rear of the home. Improvements should be made to prevent further damage.

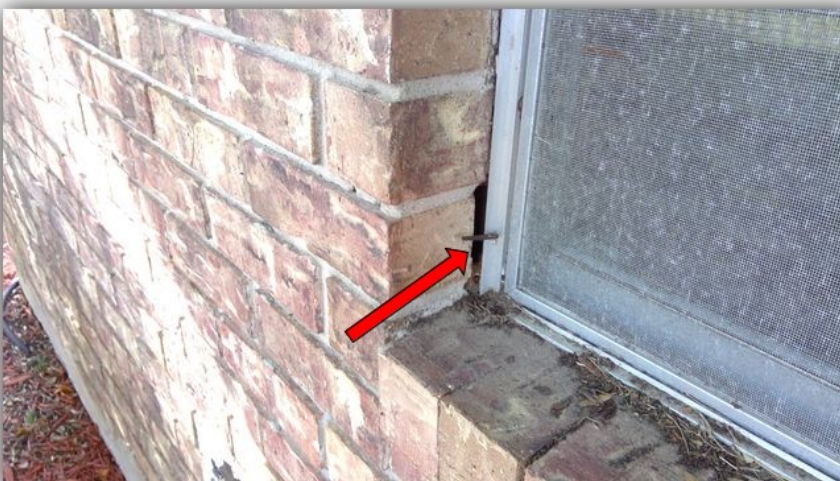
The windows should be examined and sealed at the exterior to prevent water infiltration and to improve efficiency.

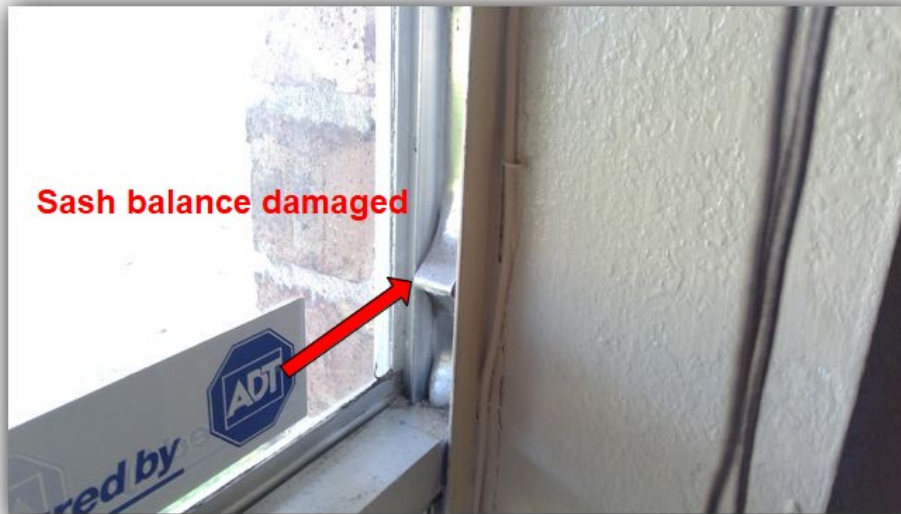
The windows are in mild disrepair. This is a common condition that does not necessitate immediate major repair. Trimming and adjustment, hardware improvements and glazing repairs would be logical long term improvements. In practice, improvements are usually made on an as needed basis only. The most important factor is that the window exteriors are well maintained to avoid rot or water infiltration.

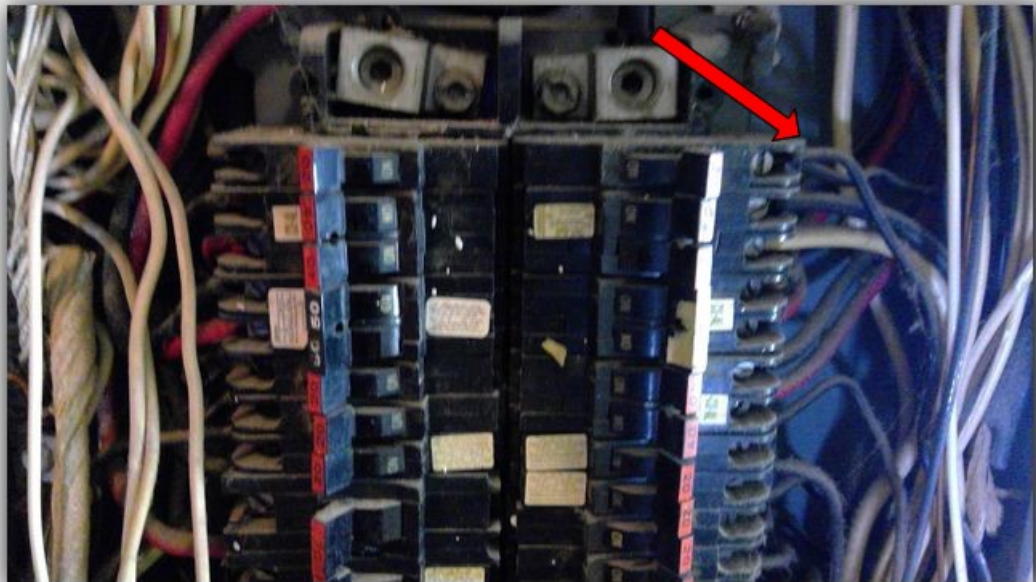
Circuits within the main distribution panel that are doubled up (referred to as "double taps") should be separated. Each circuit should be served by a separate fuse or breaker.

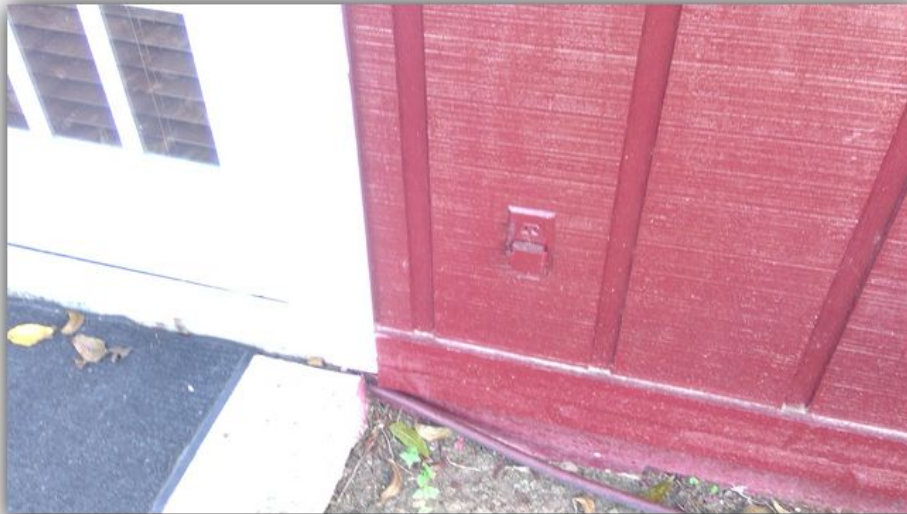
The weather cap on the exterior outlet is missing and should be replaced.

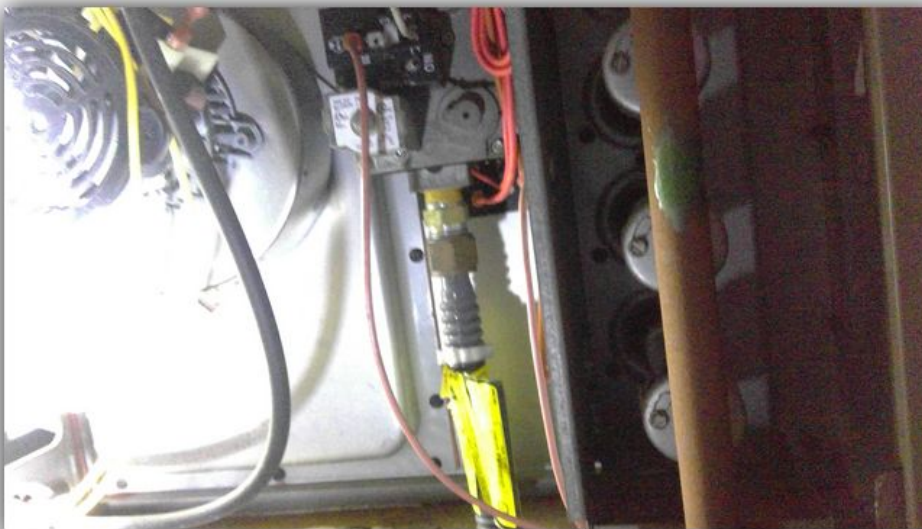
Flex gas lines that penetrate through the metal furnace cabinets is not a recommended installation by current industry standards. It is recommended that a solid gas pipe extend through the cabinet before the gas line is connected.

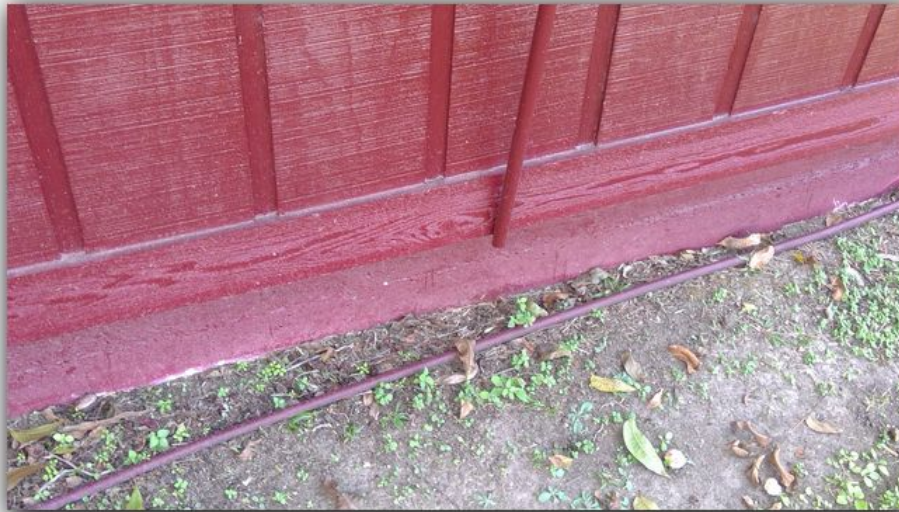
The discharge location of the condensate line for the air conditioning system should be improved.

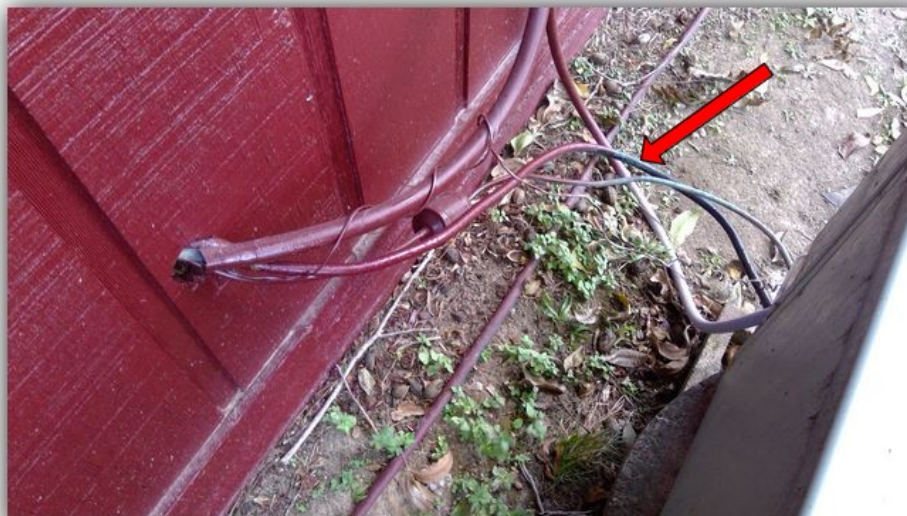
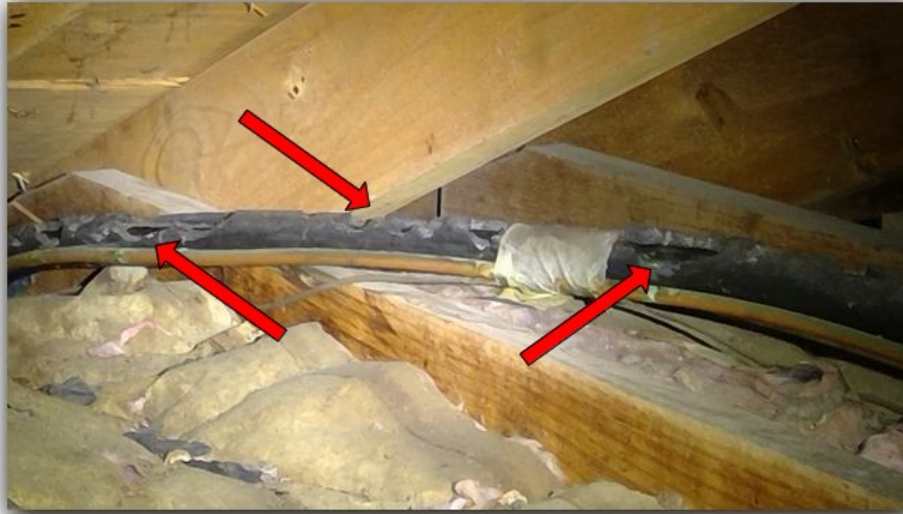
Damaged/missing insulation on condensate lines should be repaired.

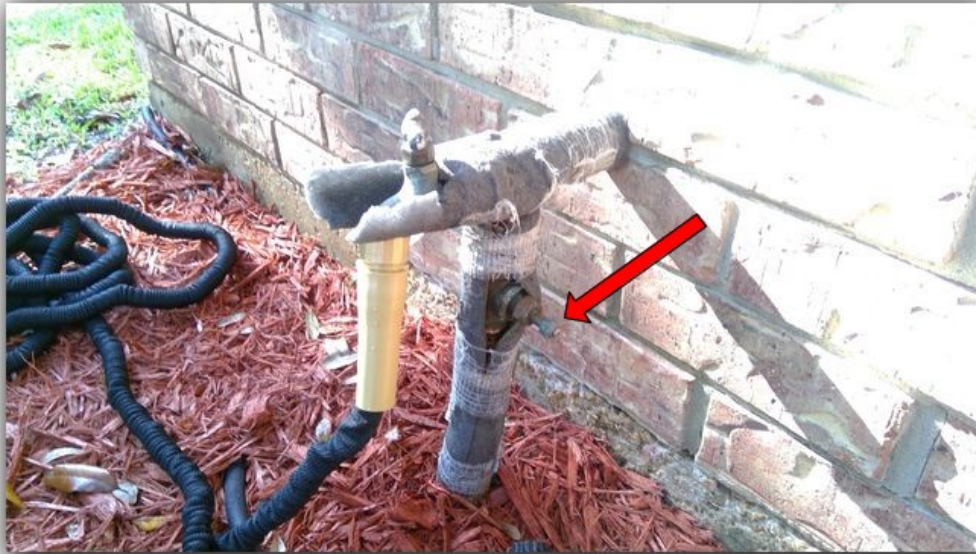
The damaged handle for the main water shut off should be replaced.

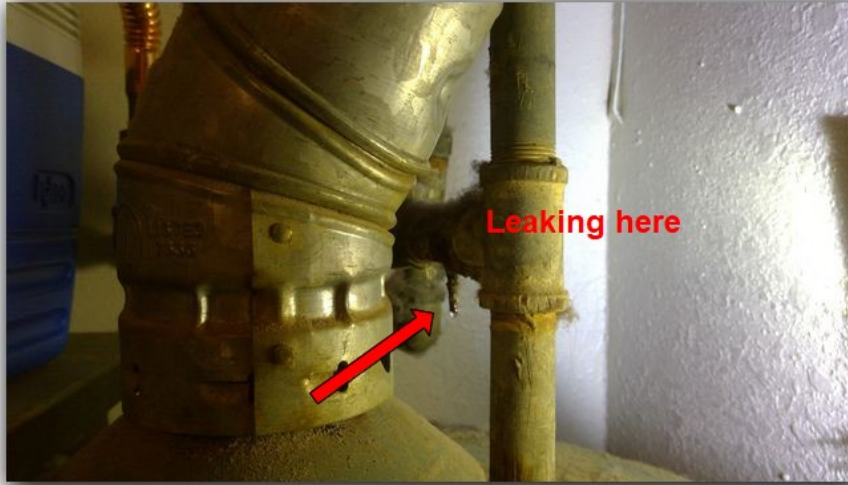
The supply piping shows evidence of corrosion where it meets the water heater. This is a common condition and should be repaired.
