PROPERTY INSPECTION REPORT

Concerning: 2806 Mezzomonte Ln, League City, TX 77573
(Address or Other Identification of Inspected Property)

By: Chad Langston, Lic #7946 04/13/2019
(Name and License Number of Inspector) (Date)

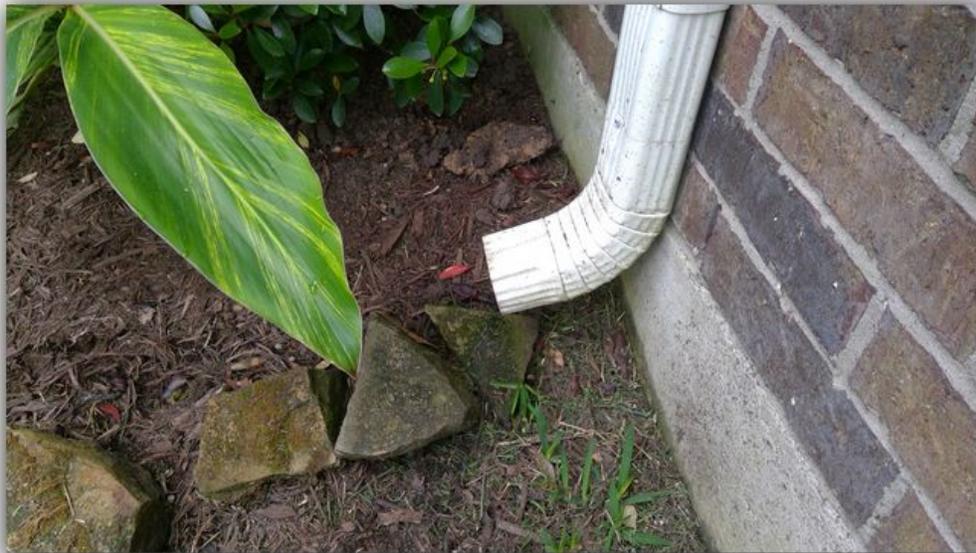
The downspout(s) should discharge water at least five (5) feet from the house. Storm water should be encouraged to flow away from the building at the point of discharge.

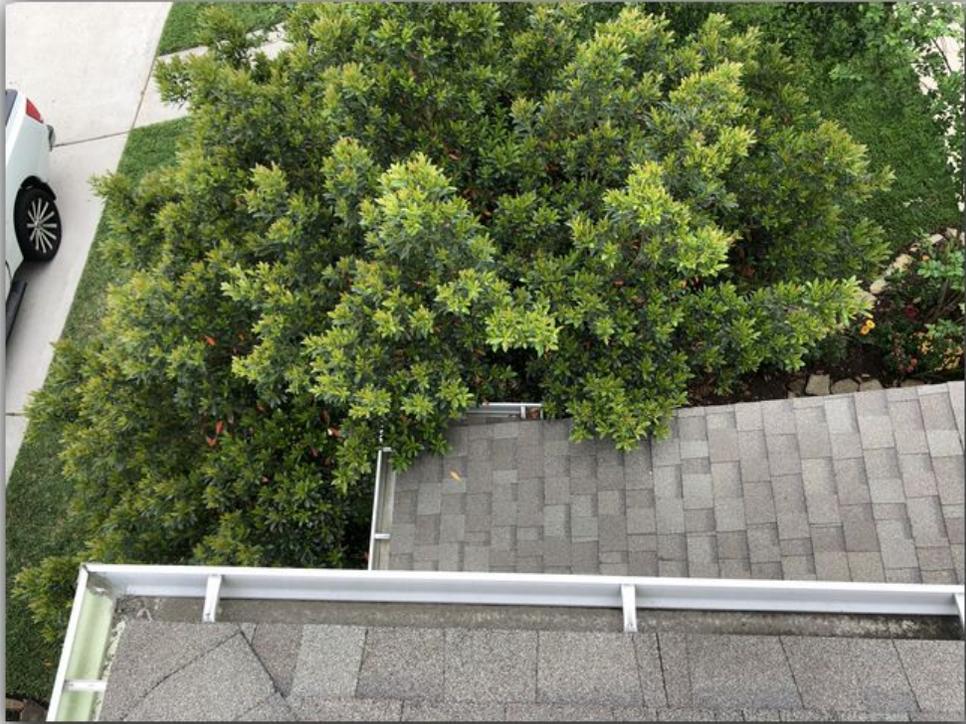
Tree branches too close to the home can damage the structure. Repairs should be made.

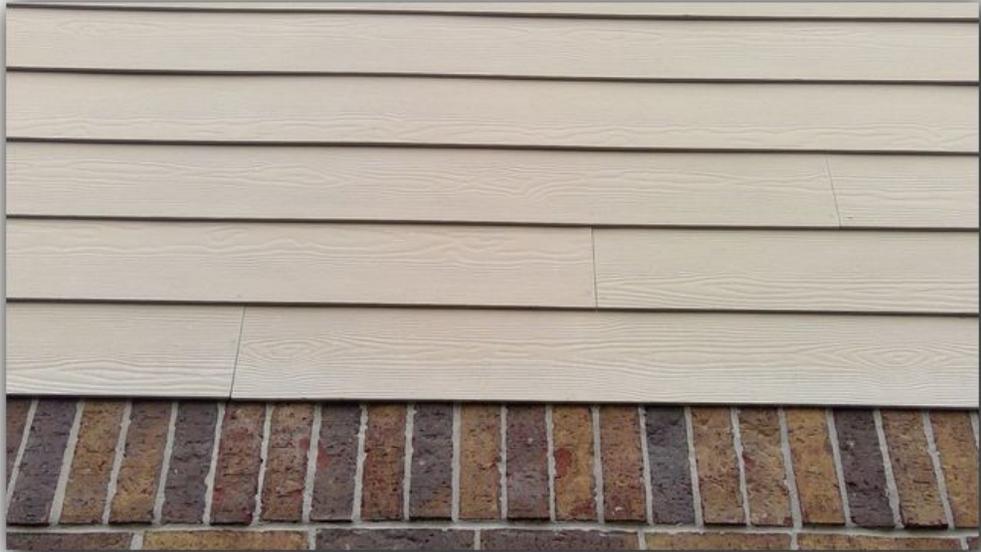
The joints in the Hardie plank should be better sealed. More information can be obtained at:

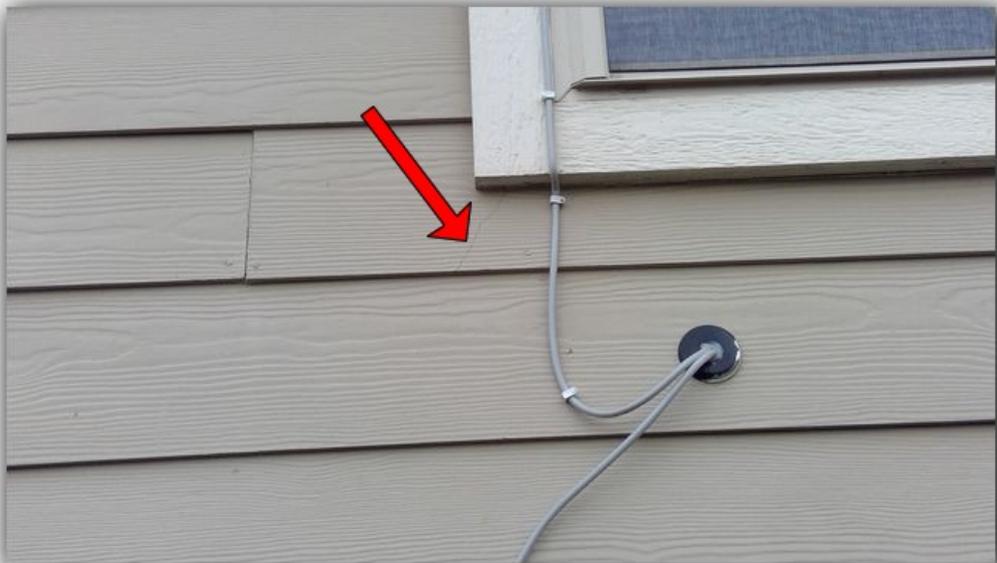
Damage to the exterior siding on the south side of the home was observed and should be repaired as necessary.

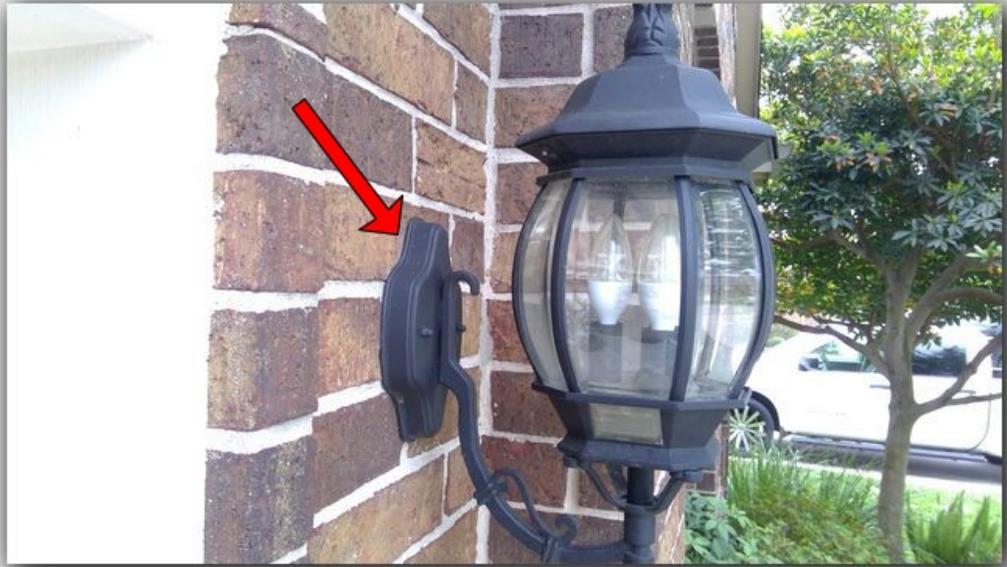
Exterior wall penetrations should be examined and sealed as necessary.

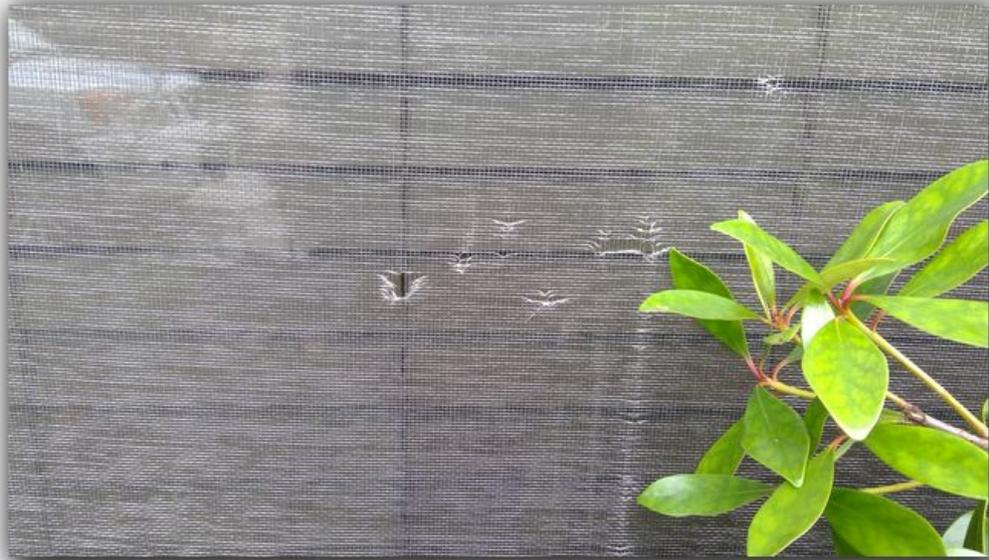
Damaged screen(s) were found on the window(s) should be repaired or replaced.

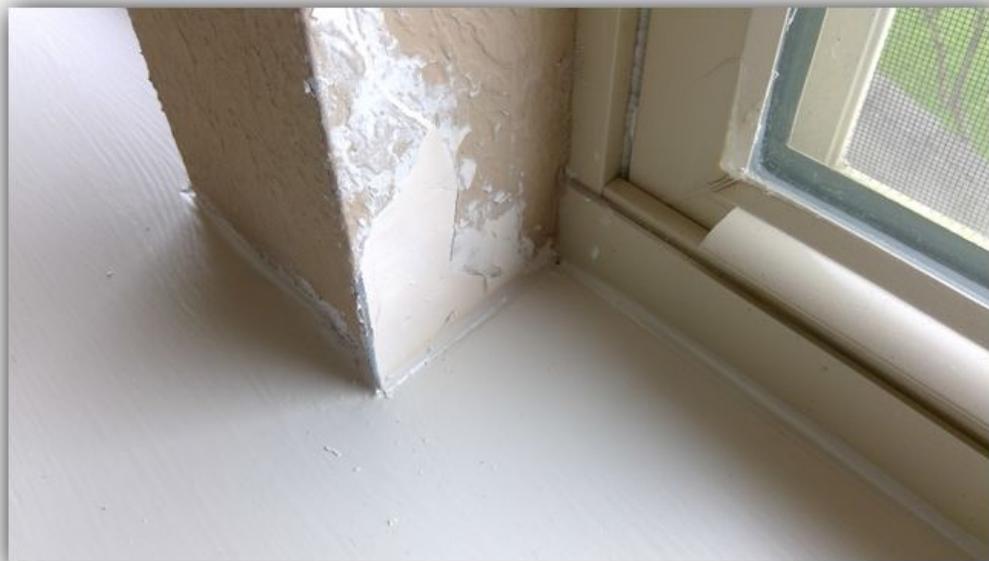
Damage was noted on the window sill in the west bedroom. Repairs should be made as necessary.

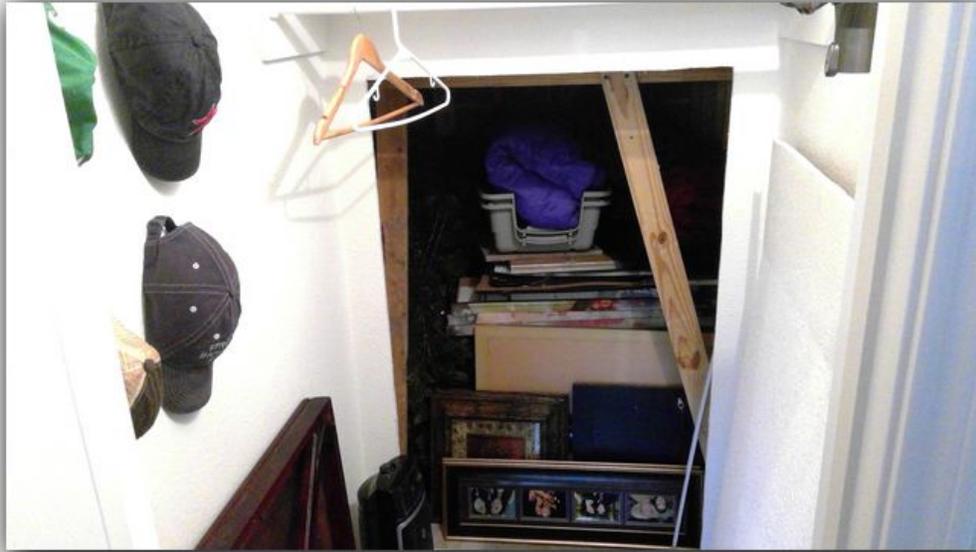
The bottom side of the stairs should be fire stopped.

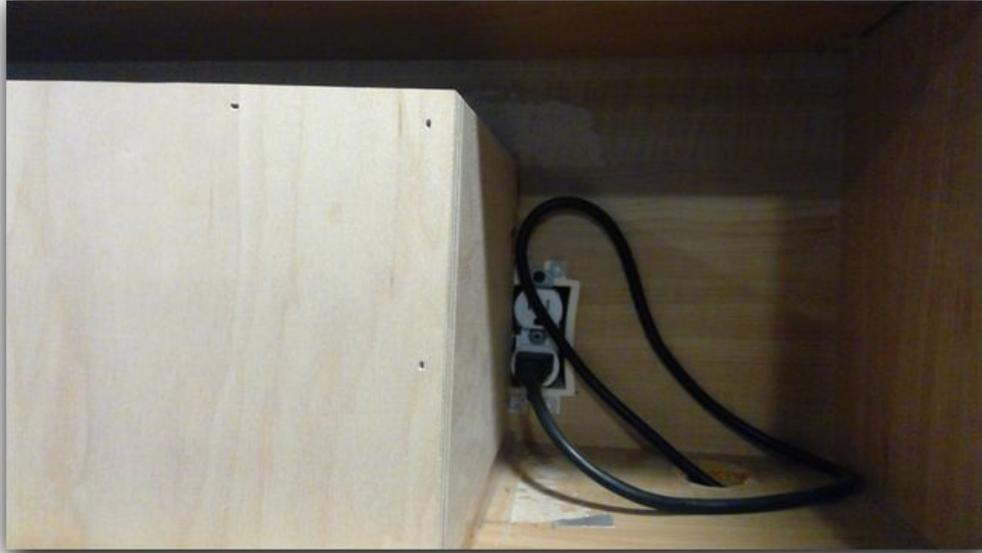
Missing outlet cover plates in the kitchen should be replaced.

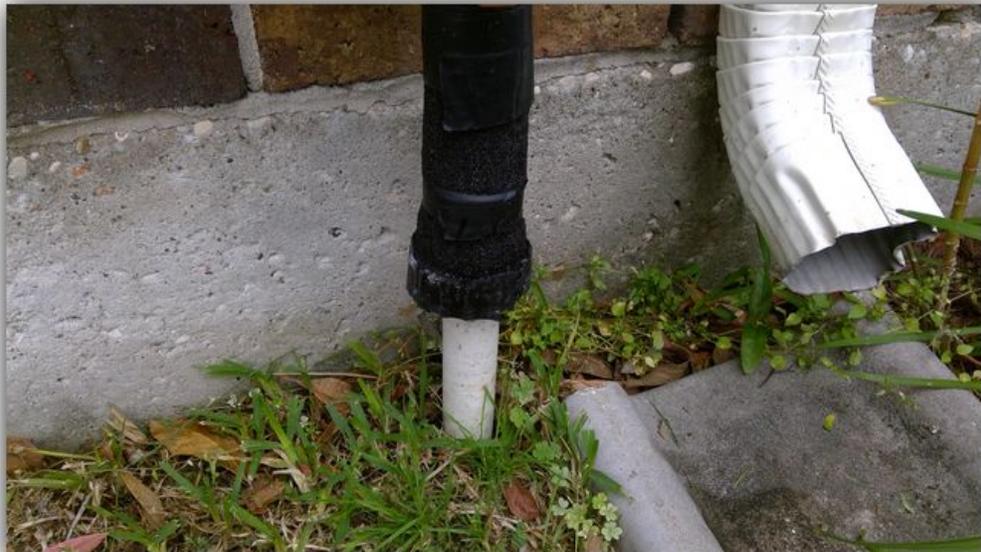
Water lines exposed on the exterior should be insulated to protect the pipe from damage during freezing temperatures.

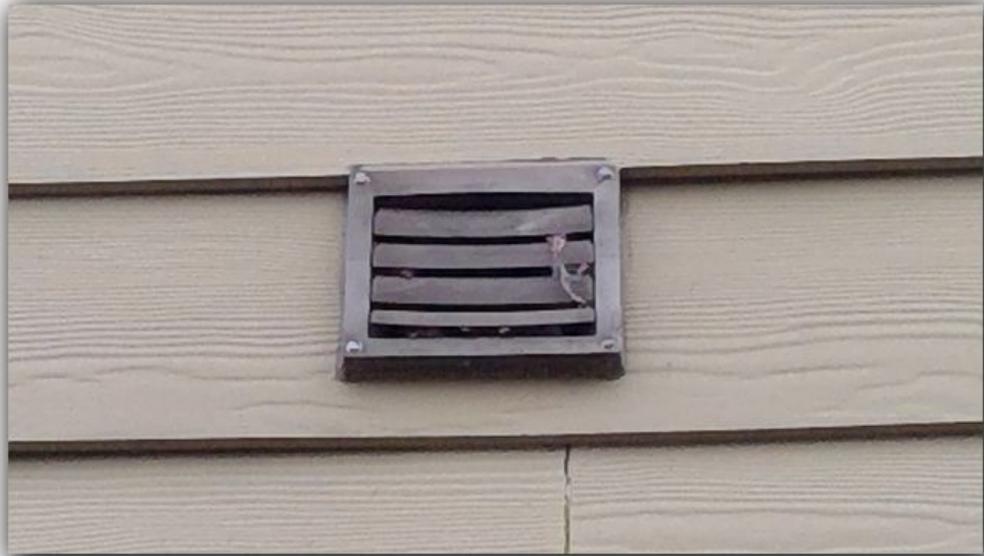
The dryer vent should be further inspected and cleaned as necessary.
