PROPERTY INSPECTION REPORT

Concerning: 111 Dunbar Estates Dr #701, Friendswood, TX 77546
(Address or Other Identification of Inspected Property)

By: Chad Langston, Lic #7946 12/19/2019
(Name and License Number of Inspector) (Date)

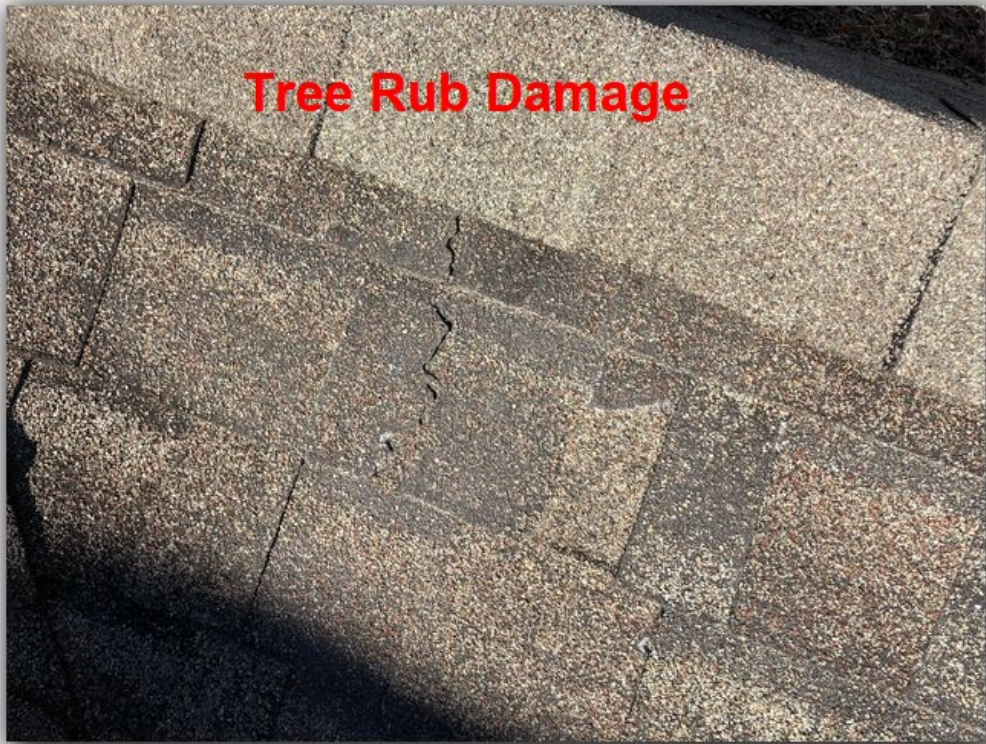
Minor repairs to the roofing are recommended. Damaged or missing roofing material should be repaired.

Minor repairs to the roofing are recommended. Damaged or missing roofing material should be repaired. Debris should be removed from the roofing.

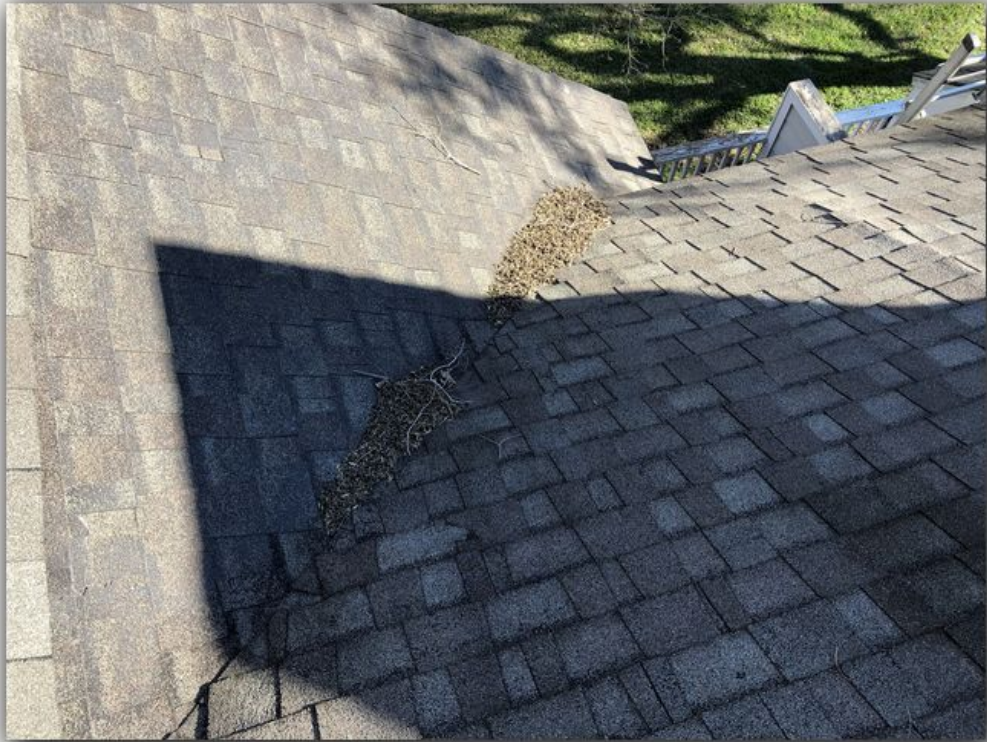
Debris should be removed from the roofing.

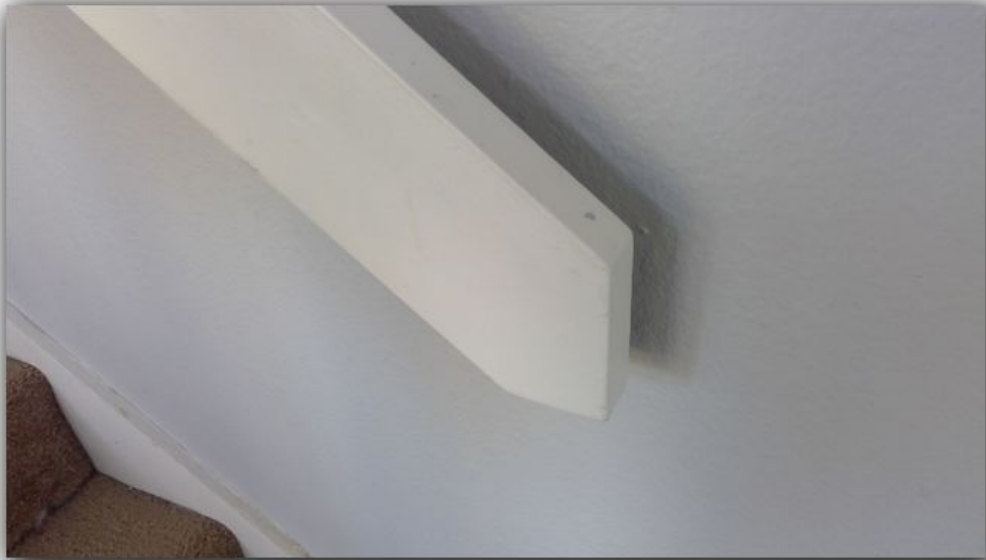
Handrails on stairways should be returned to the wall or end newel posts.

Handrails on stairways should be returned to the wall or end newel posts.

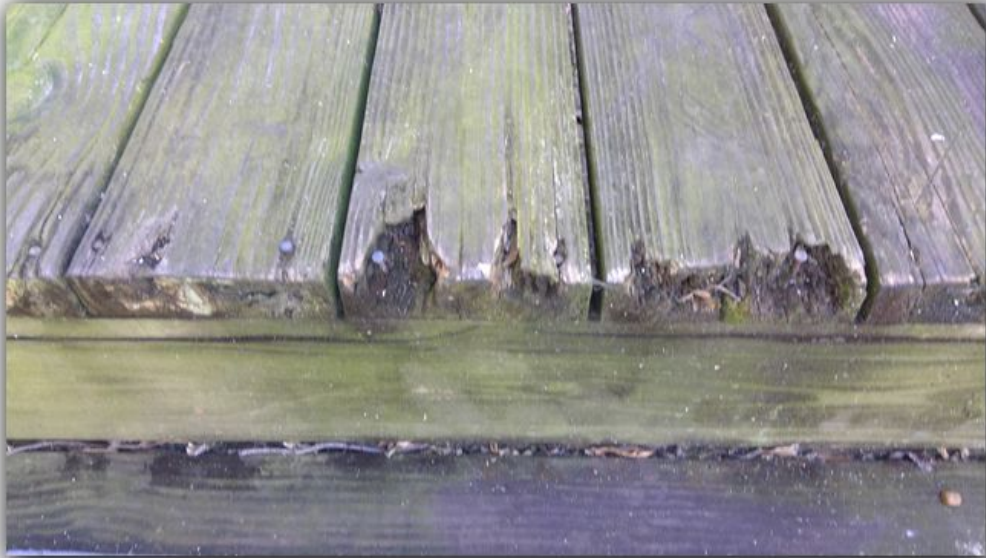
The deck shows evidence of rot. Replacement may eventually be desired. In the interim, localized repairs could be undertaken.

The deck shows evidence of rot. Replacement may eventually be desired. In the interim, localized repairs could be undertaken.
